**State of California
The Resources Agency
DEPARTMENT OF WATER RESOURCES
Division of Flood Management**

**JUNE
2003
OFFICE REPORT**

**THE INSPECTION OF FLOOD CONTROL STRUCTURES
ON THE SACRAMENTO AND SAN JOAQUIN RIVERS
AND THEIR TRIBUTARIES**

**Prepared By The
Flood Operations Branch
FLOOD PROJECT INSPECTION SECTION**

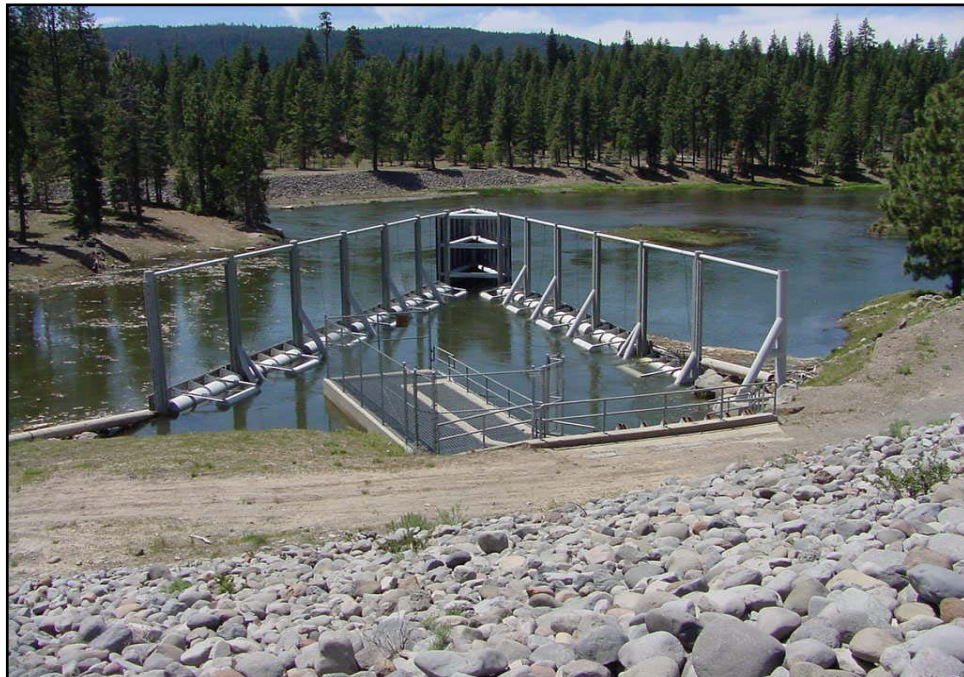
Looking at the boom and inlet from the top of the dam.

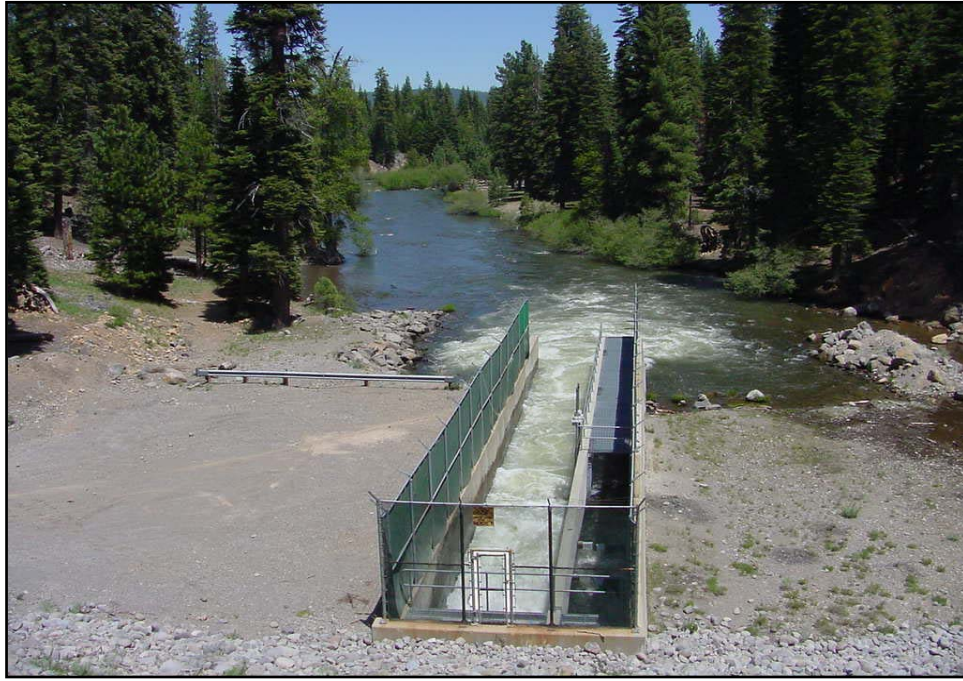
Looking at the outlet works from the top of the dam.

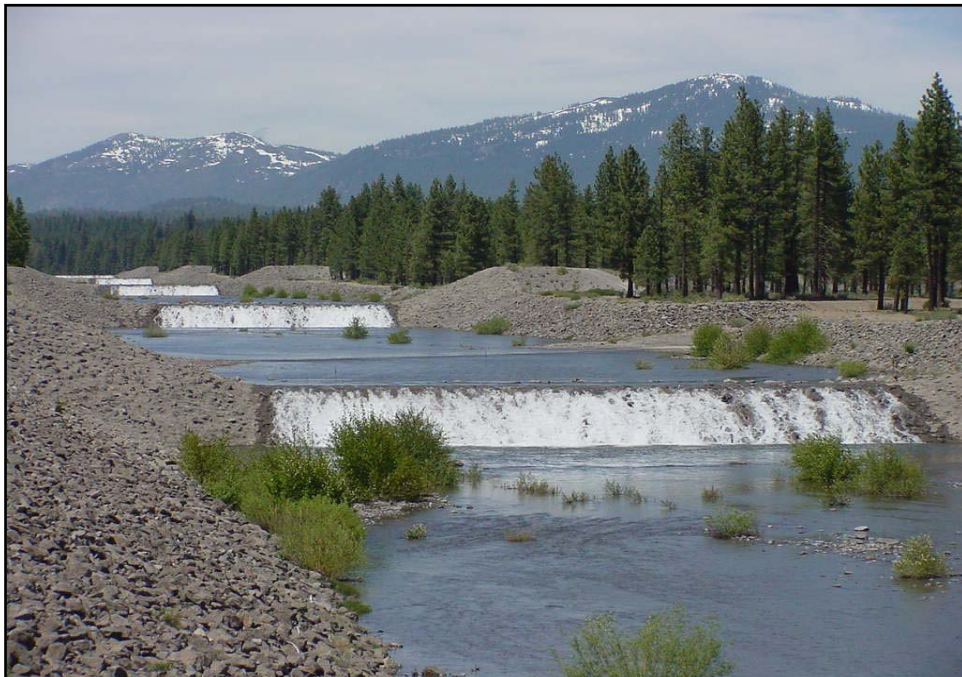
**Looking north from the Hwy 36 bridge
at drop structures 3 through 7.**

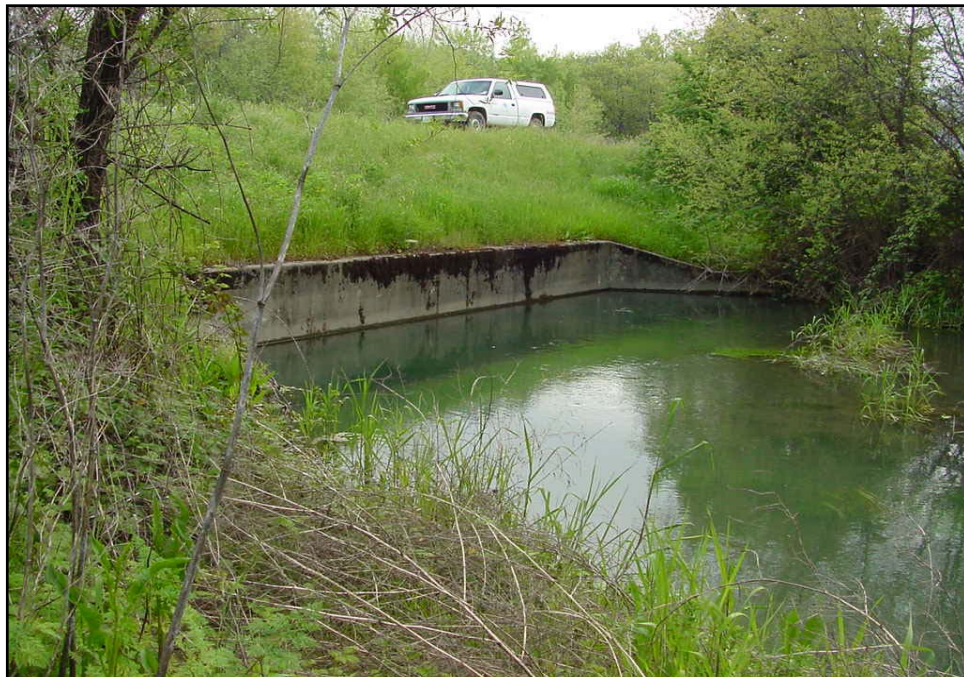
Looking at the outlet.

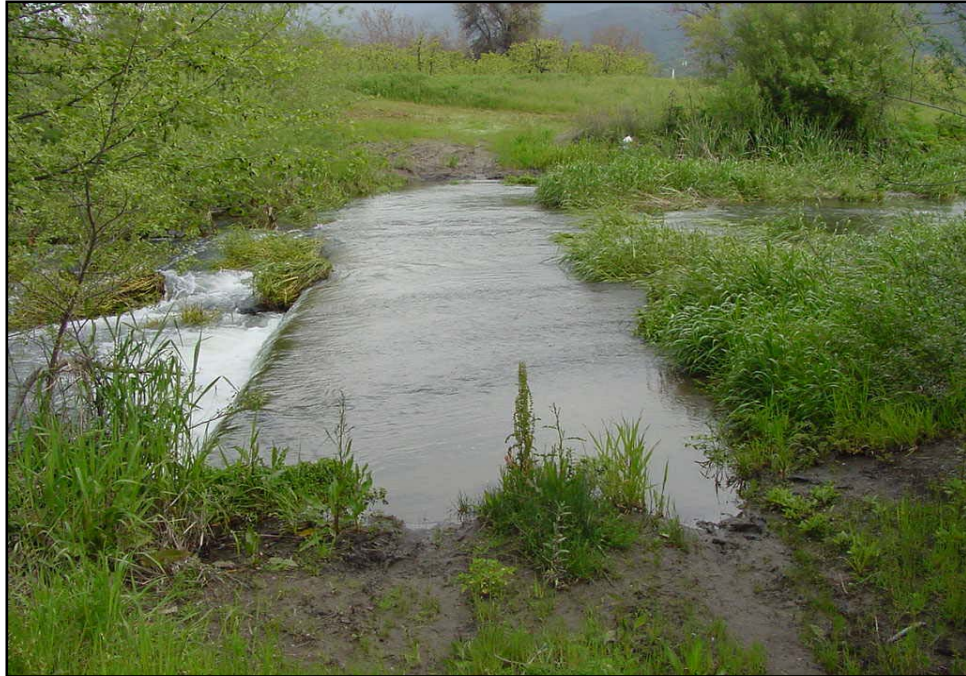
- 1. Condition of concrete weir structure.**
 - a. Good.**
- 2. Condition of the diversion structure and wing walls.**
 - a. Good.**
- 3. Condition of the bulkhead.**
 - a. Good.**
- 4. Condition of the control gates and mechanism.**
 - a. Good.**
- 5. Accumulation of trash and debris around the structures or in the channel.**
 - a. Gravel has accumulated and fills the channel to the top of the weir, this prevents water ponding upstream as it was designed to do.**
 - b. Some gravel has accumulated around the outlet side of the structure.**
- 6. Vegetation around the structures or in the channel.**
 - a. A pilot channel has been cleared upstream of the structure.**
 - b. There is dense vegetation in the creek channel, 100 feet downstream of the structure.**
- 7. Comments:**
 - a. Remove accumulated gravel upstream of weir.**
 - b. Good maintenance.**

Water flows over the concrete weir. The weir is partially ineffective due to gravel accumulation upstream.

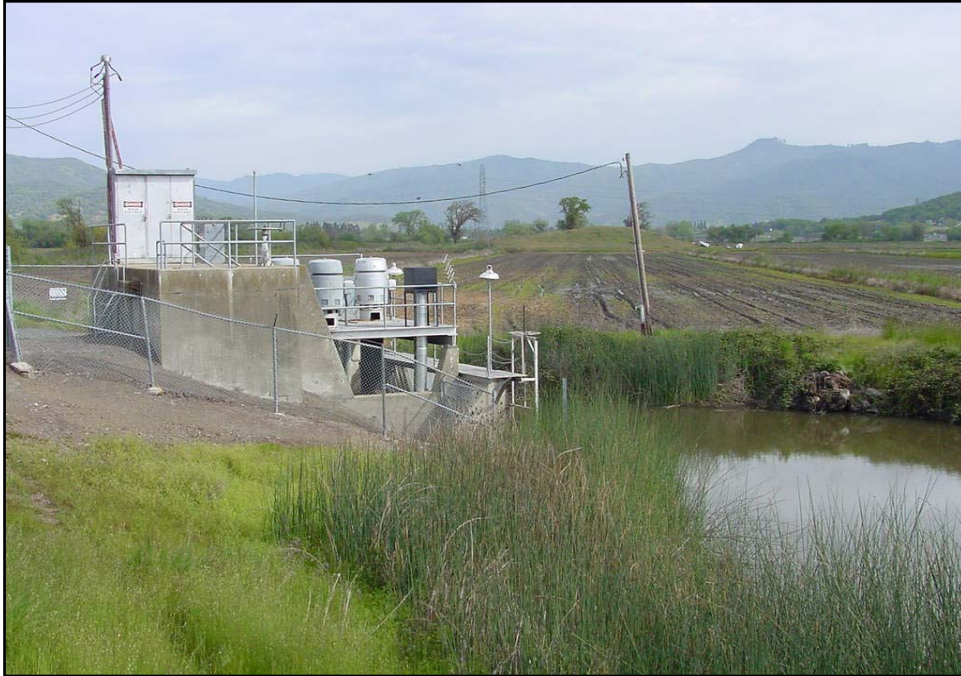
1. Condition of main pump structure and switchboard house.
 - a. Poor. The separation between the top of the surge box and the structure appears to have an eight and one half inch side displacement. The surge box has settled twelve inches since 1962 and is 7.6 feet below the top of the structure. There is approximately a two inch deflection. There have been no changes since last reported.
2. Condition of pumps and motors.
 - a. Good.
3. Condition of electrical equipment.
 - a. Good.
4. Condition of control gates, mechanisms, and flap gates.
 - a. Good.
5. Condition of the trash racks.
 - a. Good.
6. Condition of log boom.
 - a. Good.
7. Condition of hydrographic facilities.
 - a. Good.
8. Accumulation of trash or debris in the sump.
 - a. None.

Looking north at the pumping plant from the left bank levee.

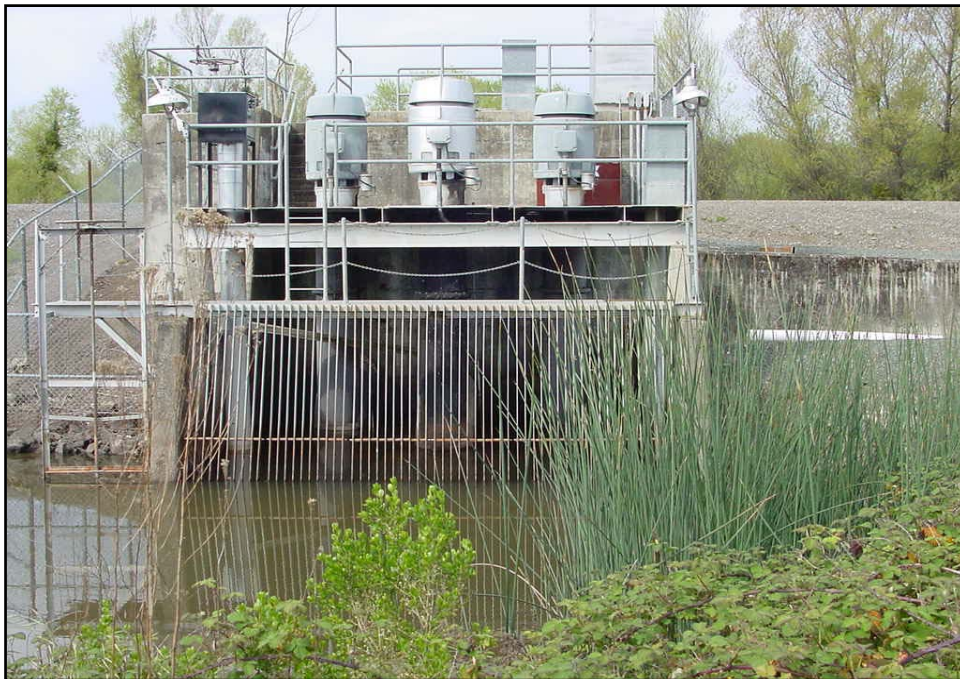
Looking upstream at the intake side of the pumping plant.

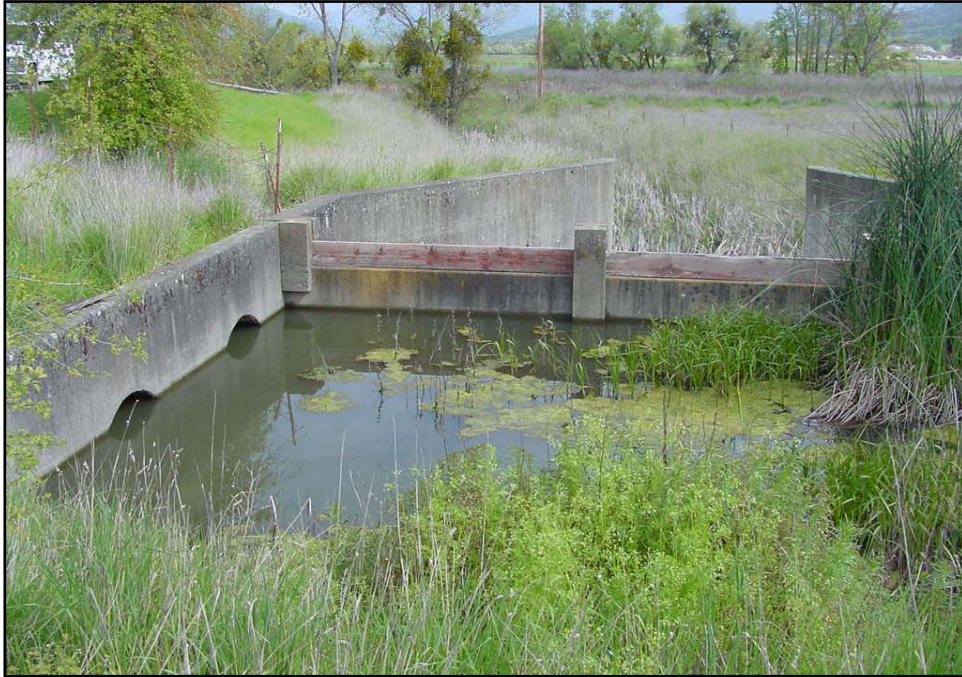
Looking at the concrete weir and diversion pipe intake.

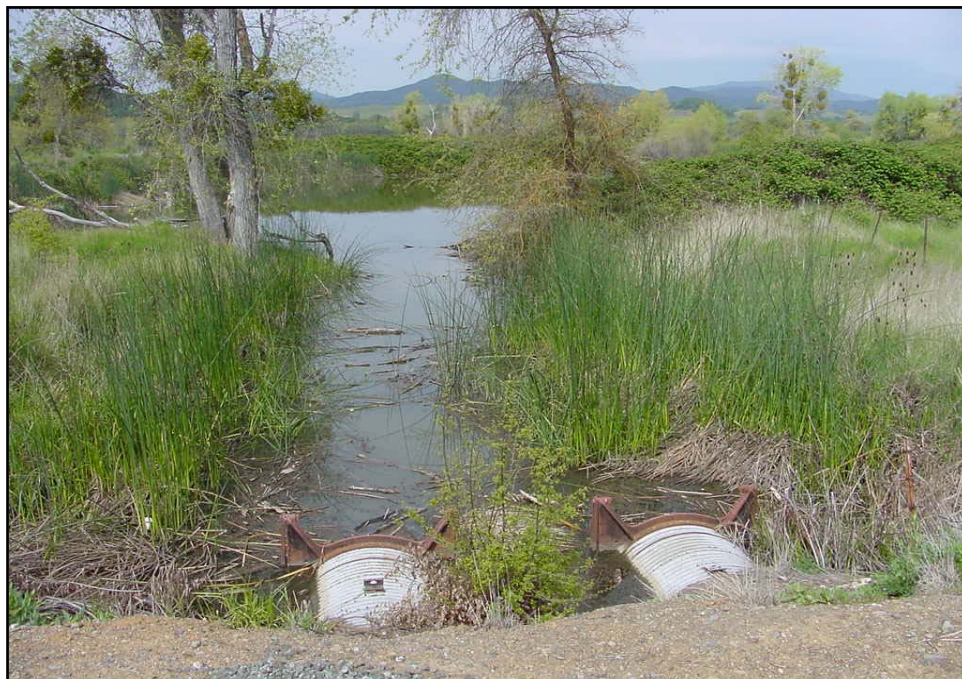
Looking at the outlet channel and the diversion pipes.

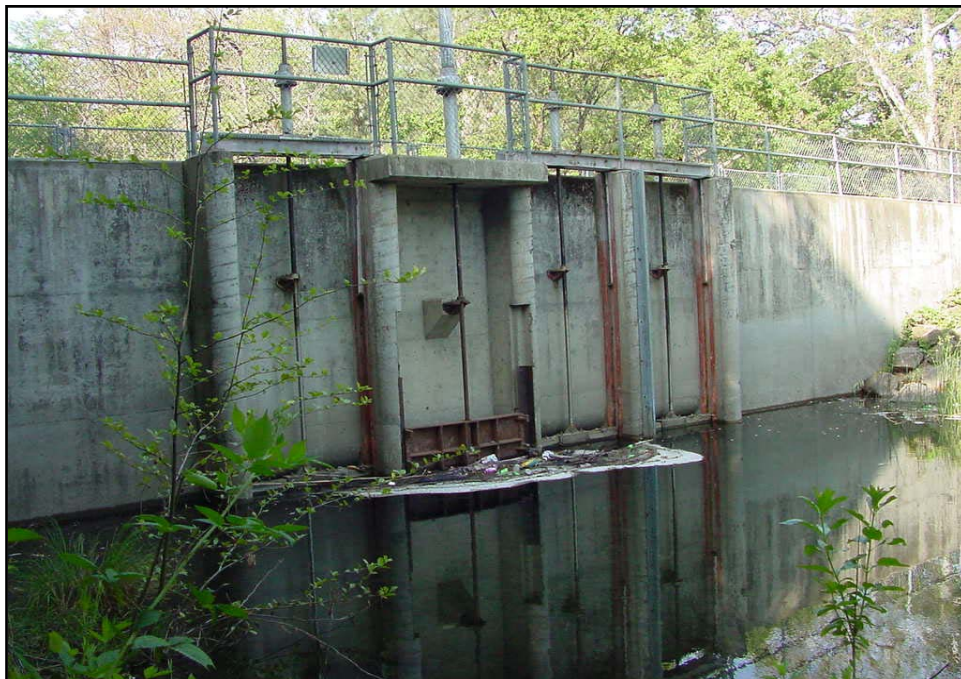
Looking at the upstream side of the structure.

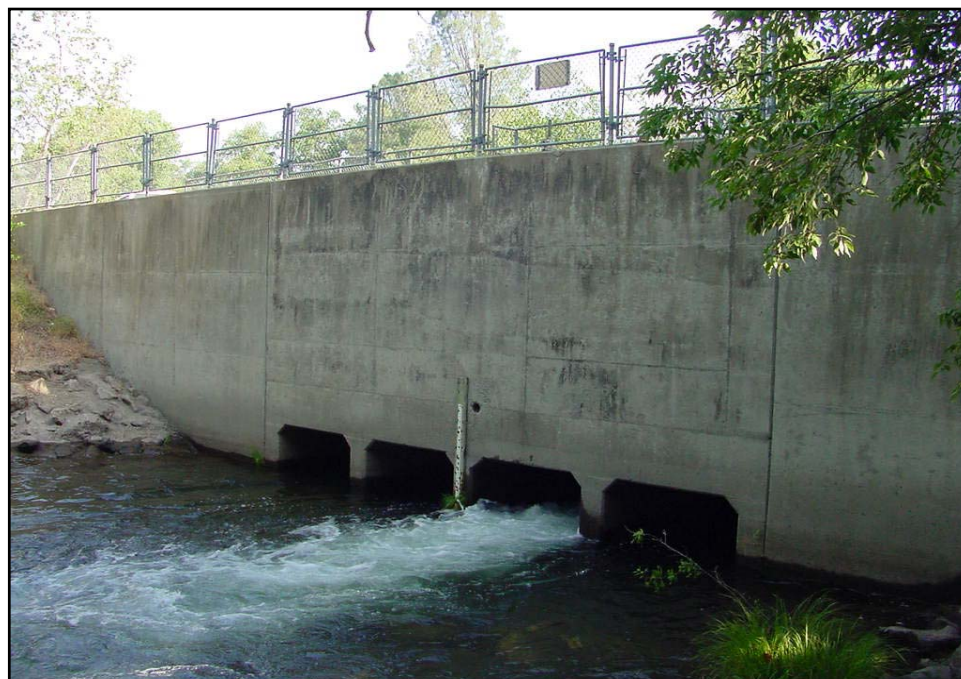
Looking at the discharge side of the structure.

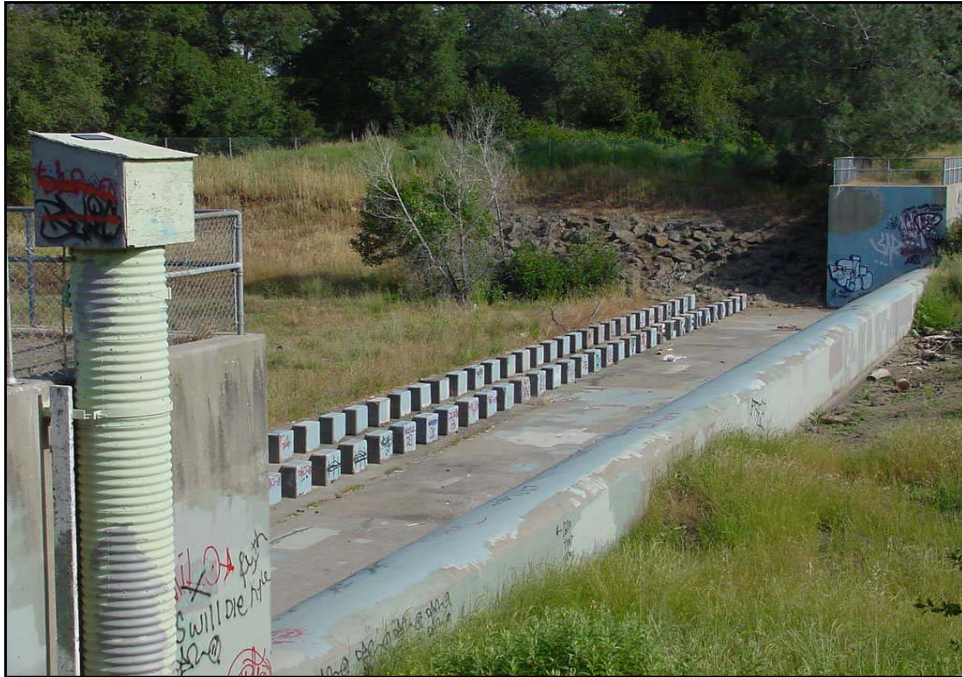
Upstream side of the structure from the left bank.

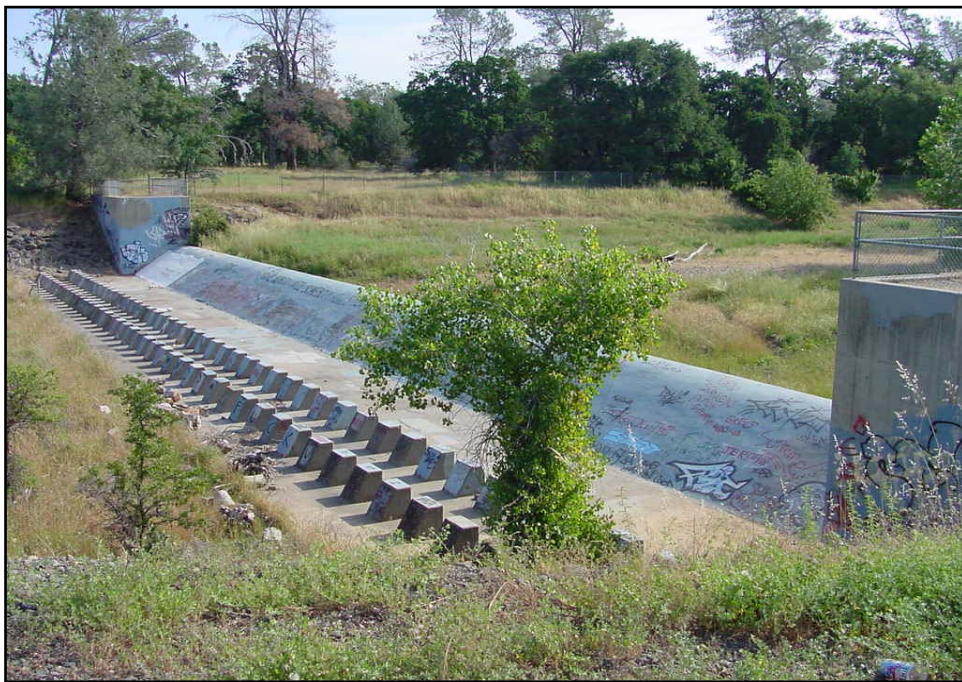
1. **Condition of concrete weir structure and stilling basin, and velocity dissipaters.**
 - a. **There are minor joint separations on the north and south ends of the weir where it contacts the abutments.**
 - b. **There is minor damage to several velocity dissipaters and severe damage to one.**
2. **Condition of concrete abutments and wing walls.**
 - a. **Good.**
3. **Condition of revetment.**
 - a. **Good.**
4. **Accumulation of trash and debris around the structure or in the channel.**
 - a. **None.**
5. **Vegetation around structure or in the channel.**
 - a. **Minimal.**
6. **Condition of gauging house and equipment.**
 - a. **Fair.**
7. **Comments:**
 - a. **Repair the severely damaged velocity dissipater.**
 - b. **Remove vegetation from channel.**
 - c. **Fair maintenance.**

The velocity dissipaters on the downstream side of structure from the left bank.

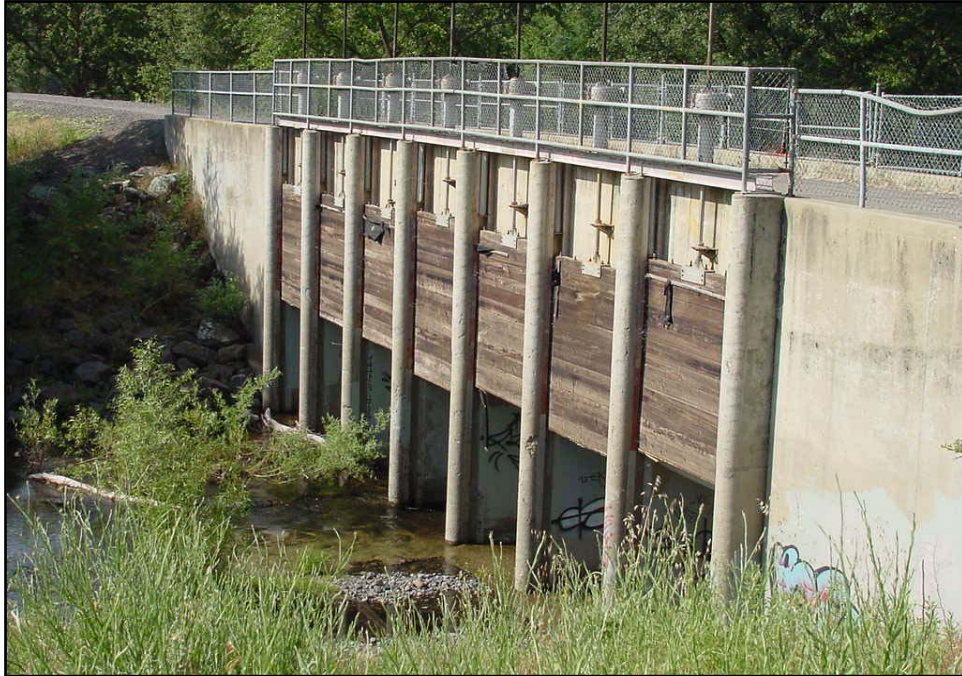
Downstream at intake side of structure.

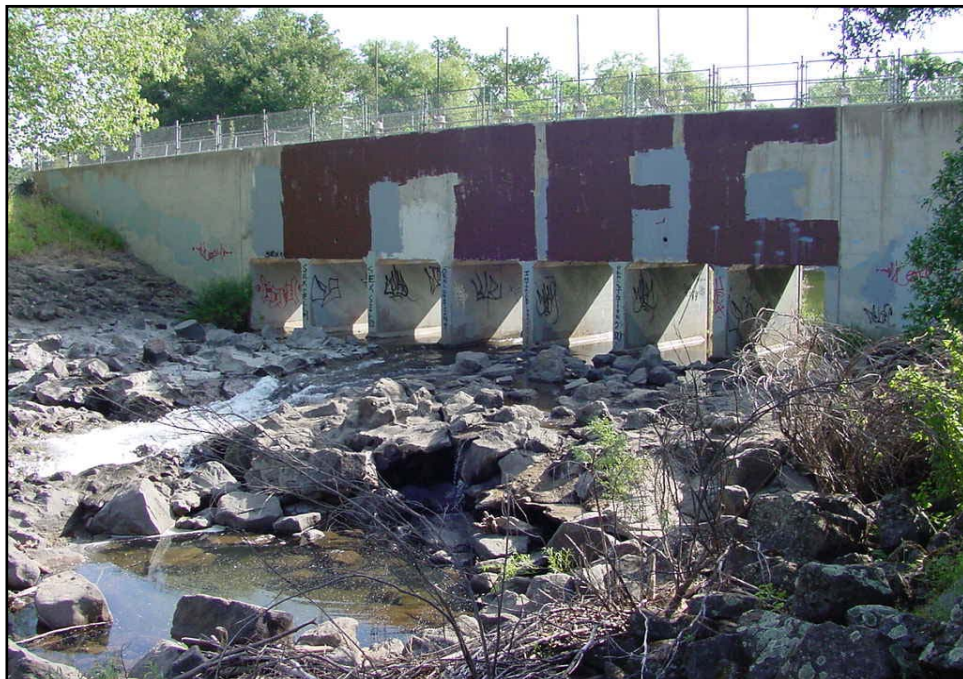
Upstream at discharge side of structure.

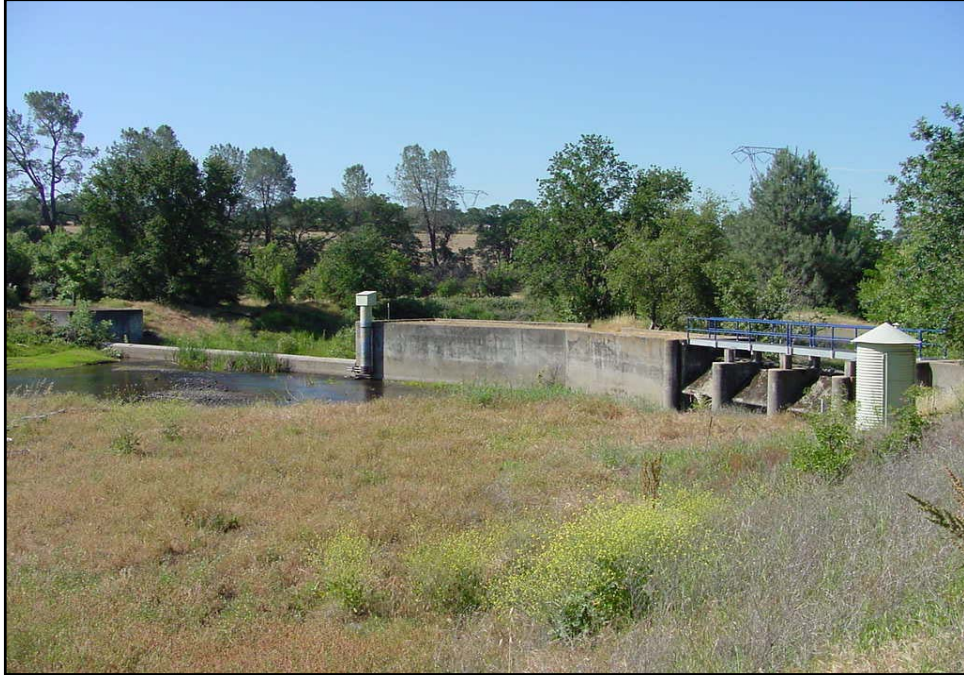
View of the upstream side of the control structure and weir.

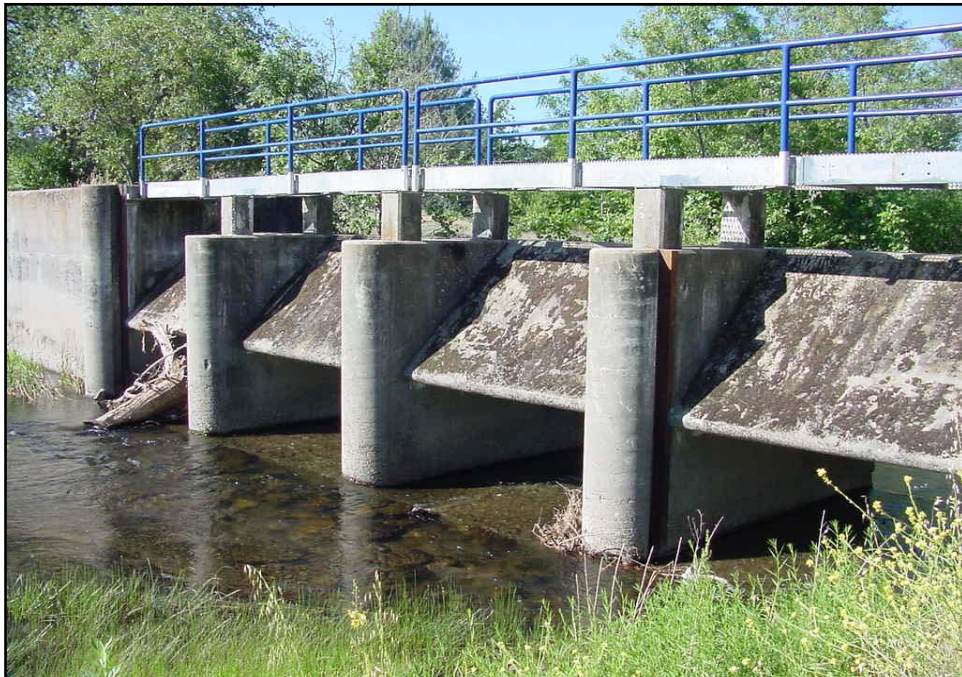
Looking at the upstream side of the control structure.

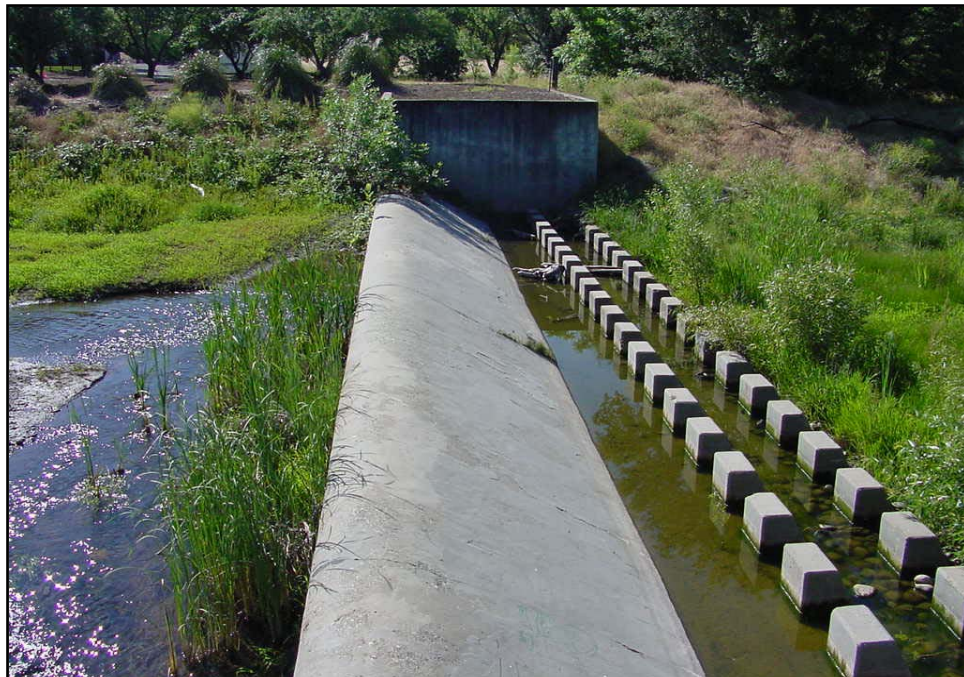
- a. Previously reported separations and displacements are stable.
3. Condition of concrete weir, stilling basin, and velocity dissipaters.
 - a. Minor cracks in the weir and minor spalling of concrete on the weir invert.

Looking at the weir and velocity dissipaters.

- a. Repair the control structure base (downstream side) as soon as possible.**
- b. Continue to monitor joint separation between the control structure and the abutments and repair as needed.**
- c. Remove driftwood and cobbles from dissipaters.**
- d. Fair maintenance.**

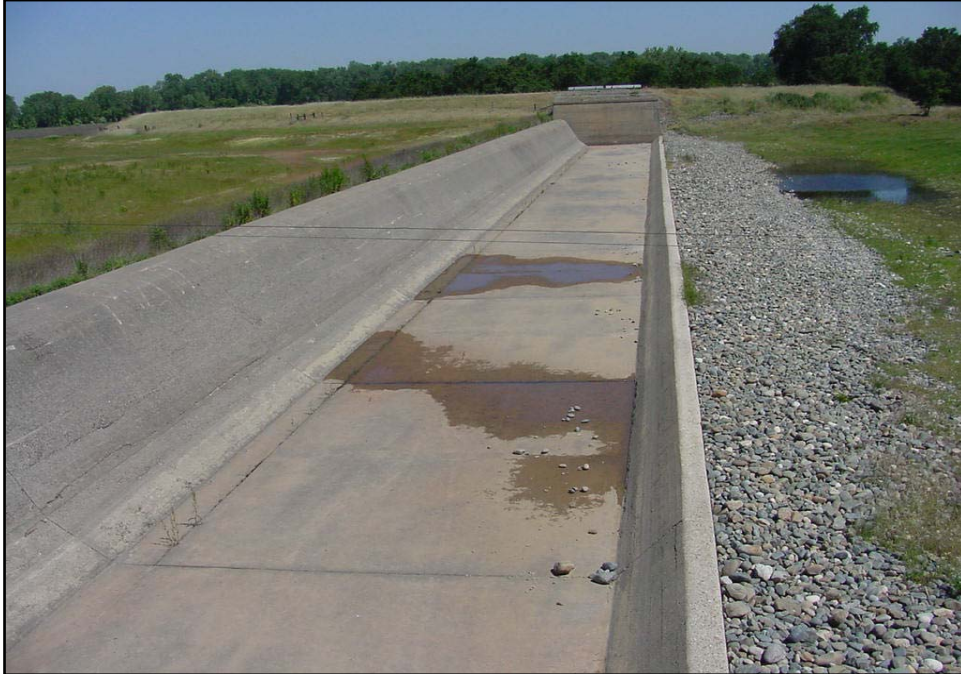
Looking north at the weir and stilling basin from the left abutment.

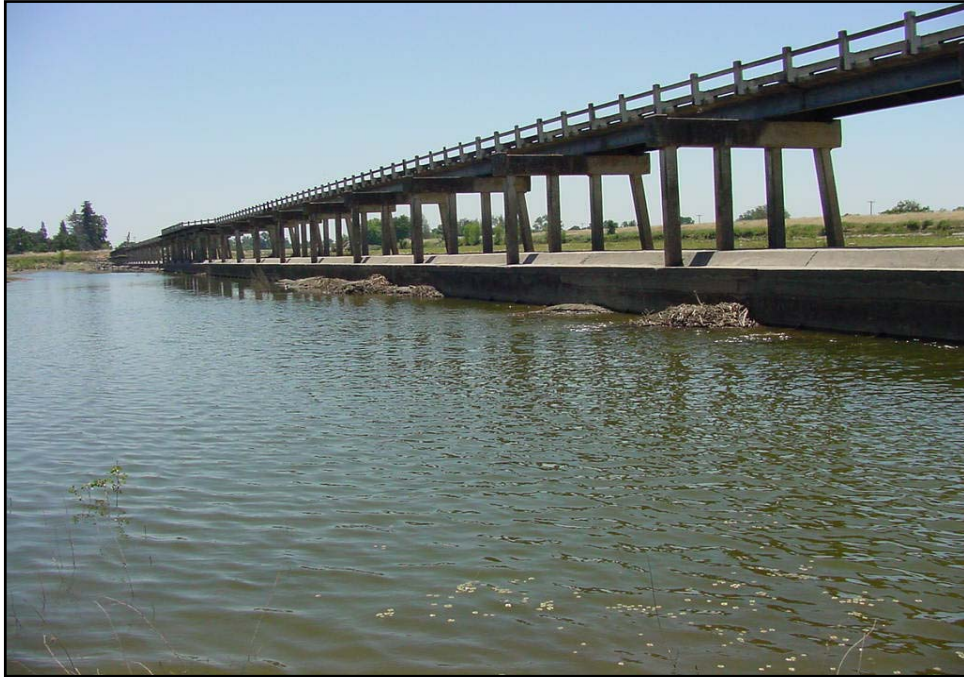
Looking at the downstream side of the weir from the north end.

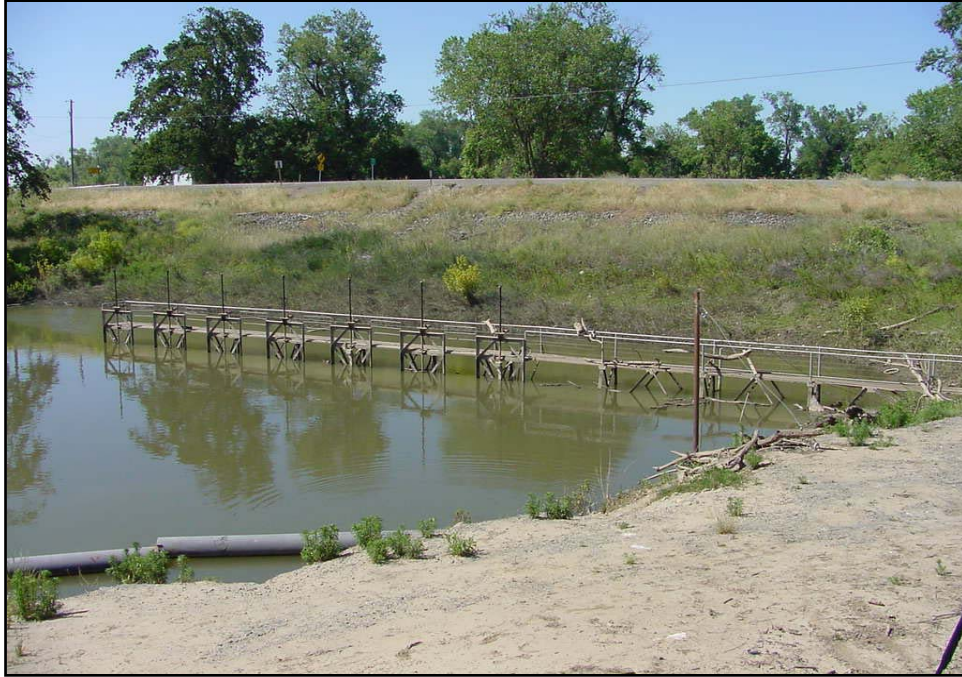
Looking at the intake side of the structure.

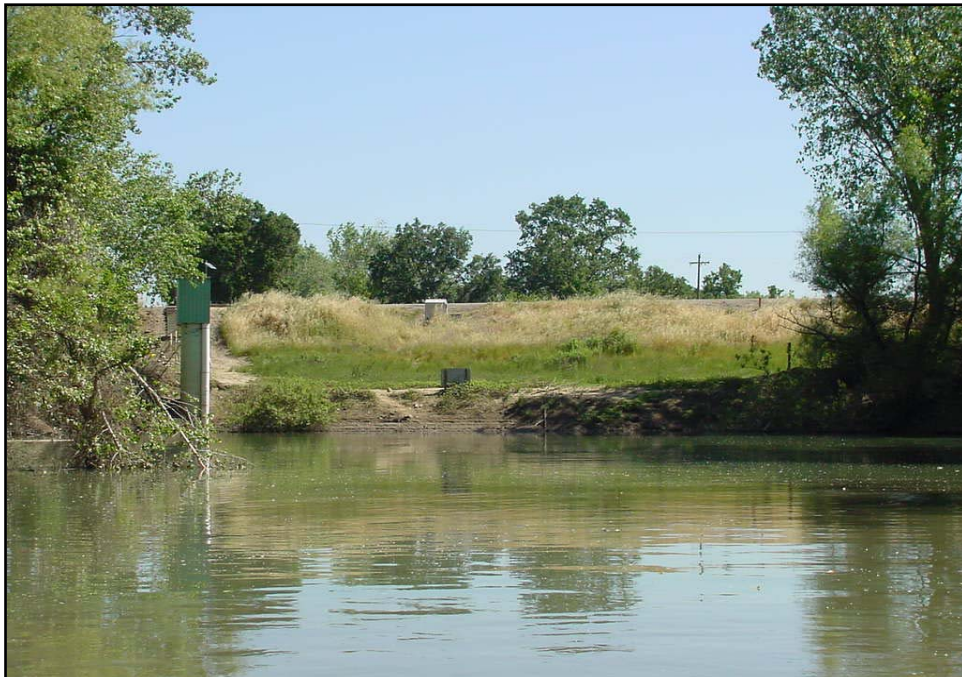
Looking at the outlet channel of the structure.

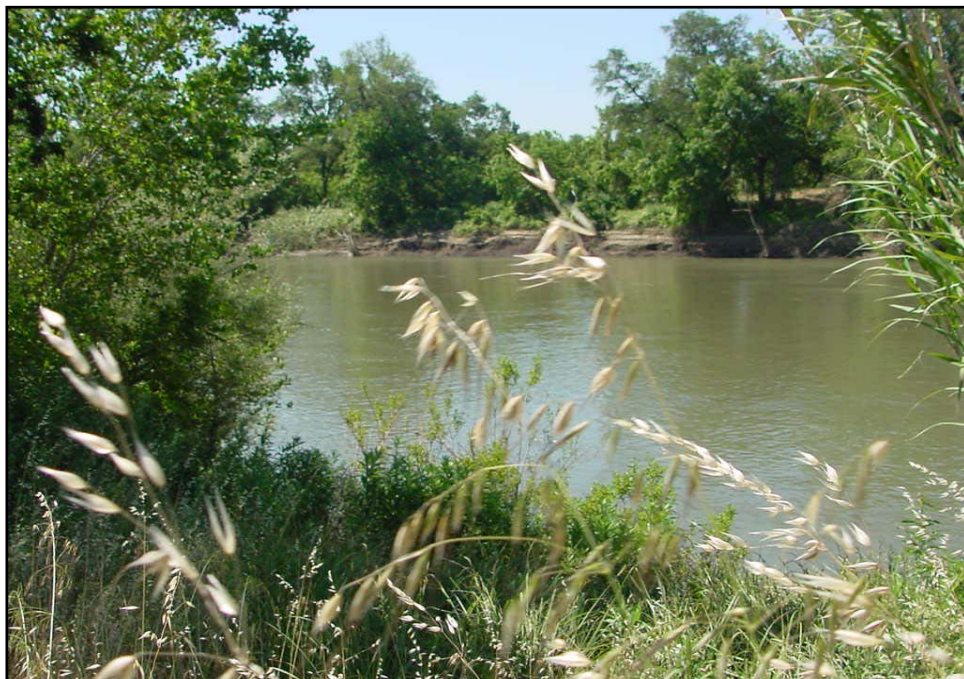
**Looking at the Sacramento River in the general direction of the outlet.
The outlet would be on the left bank (foreground).**

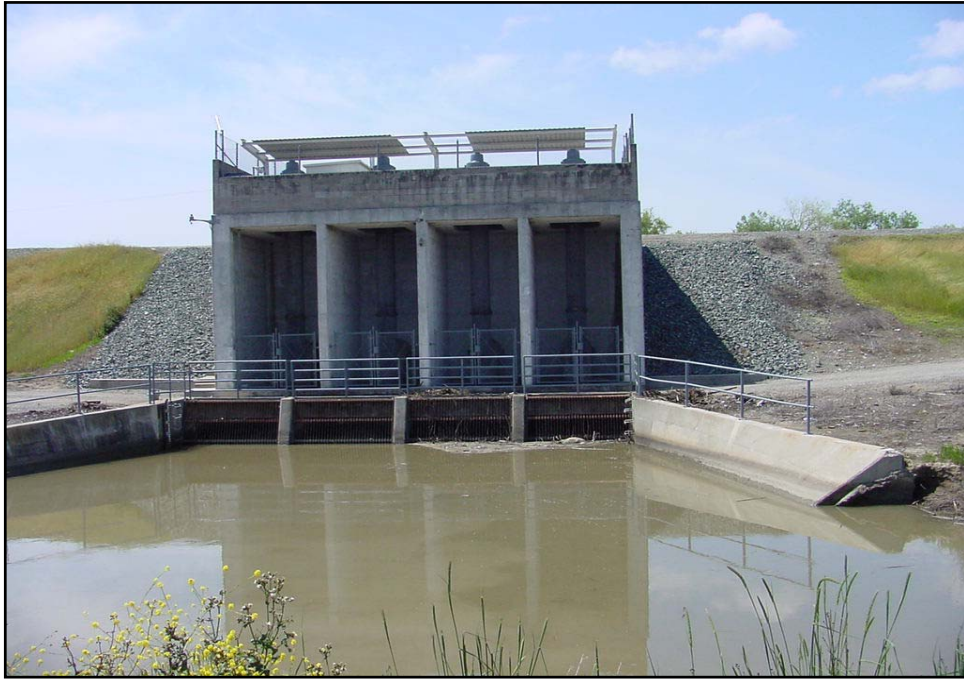
Looking at the intake side of the pumping plant.

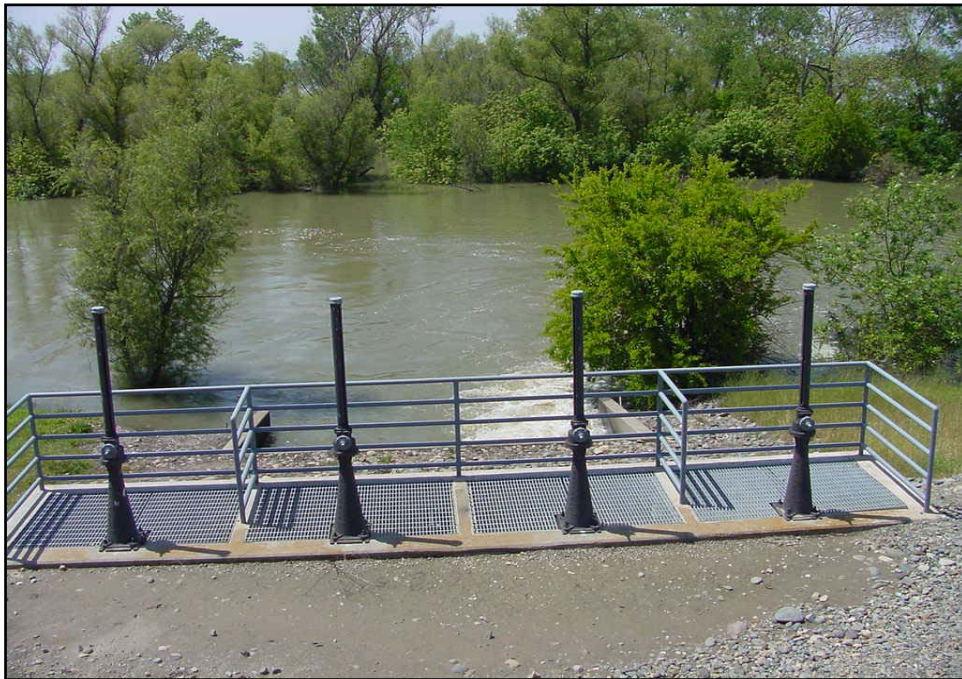
Looking at the discharge side of the pumping plant.

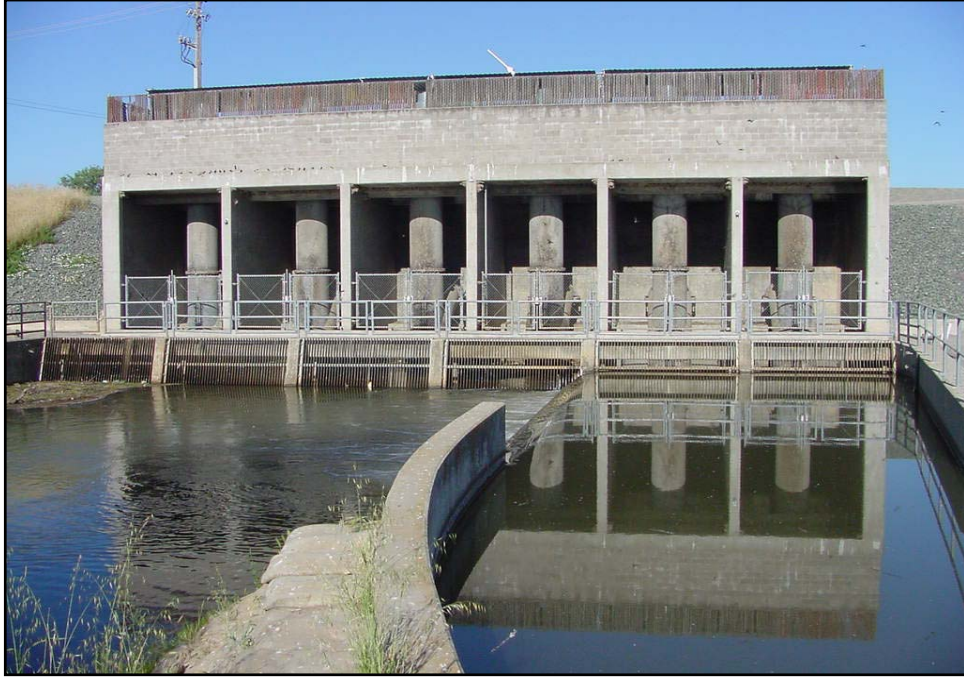
Looking at the pumping plant, sump and trash racks from the intake side.

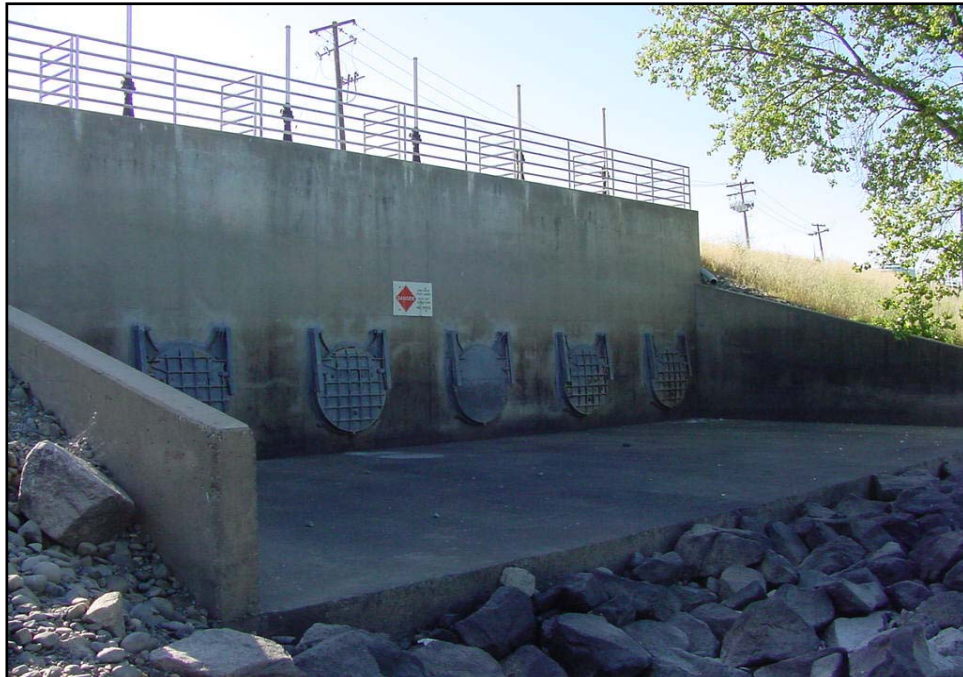
Looking at the discharge side of the pumping plant.

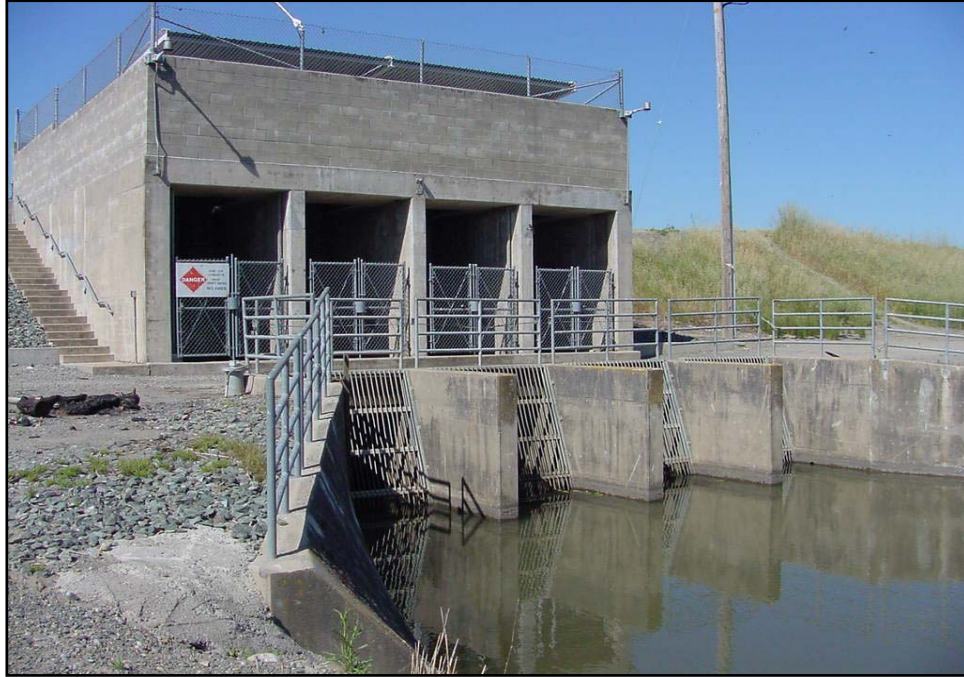
Looking at the inlet side of the pumping plant.

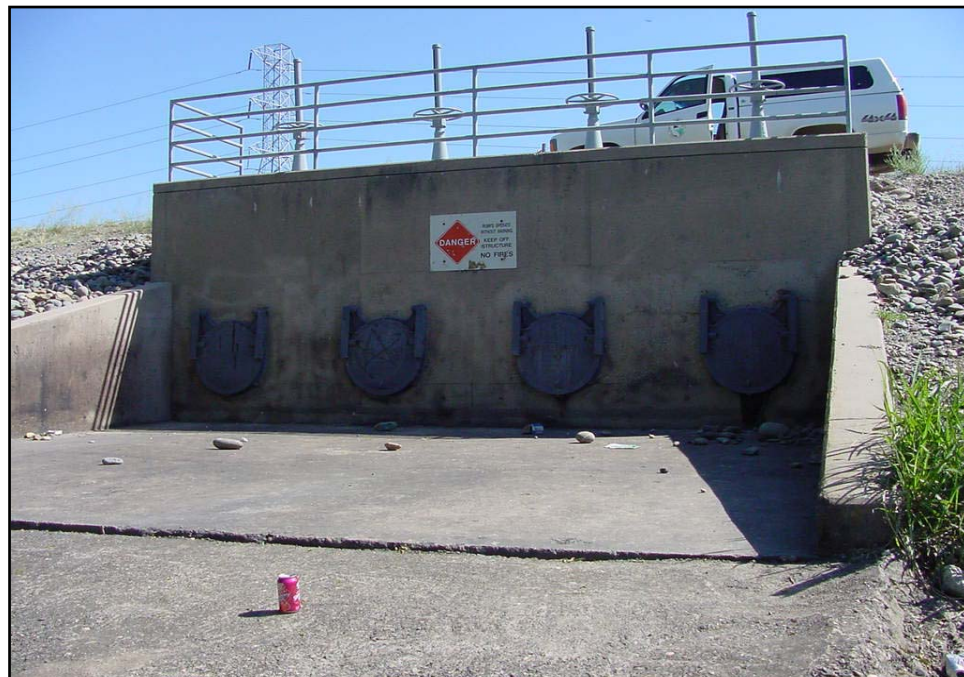
Looking at the discharge side of the pumping plant.

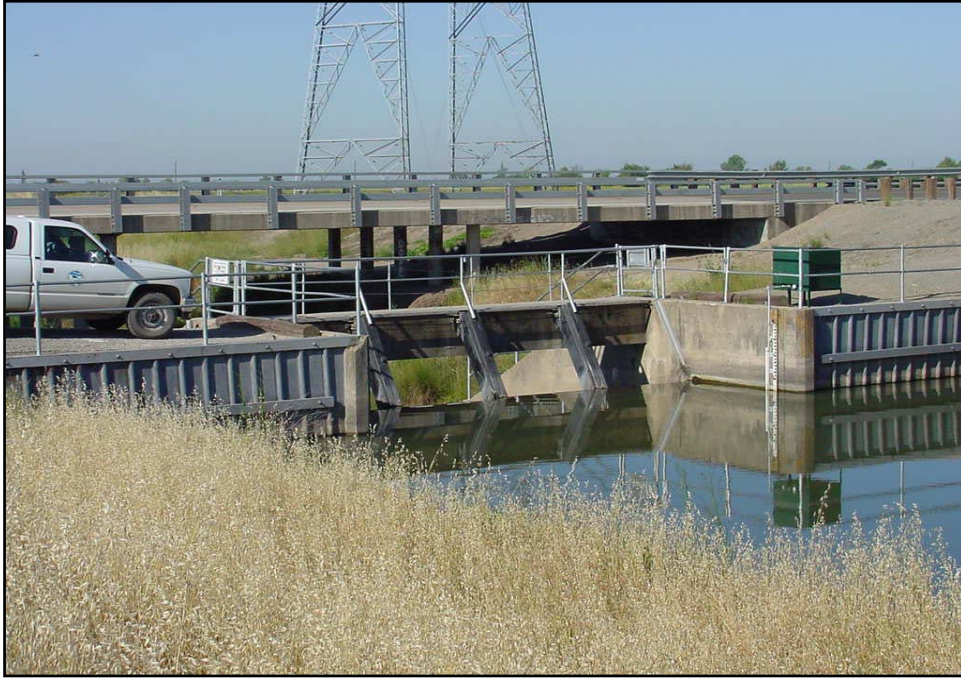
Looking at the upstream side of structure from the left bank levee.

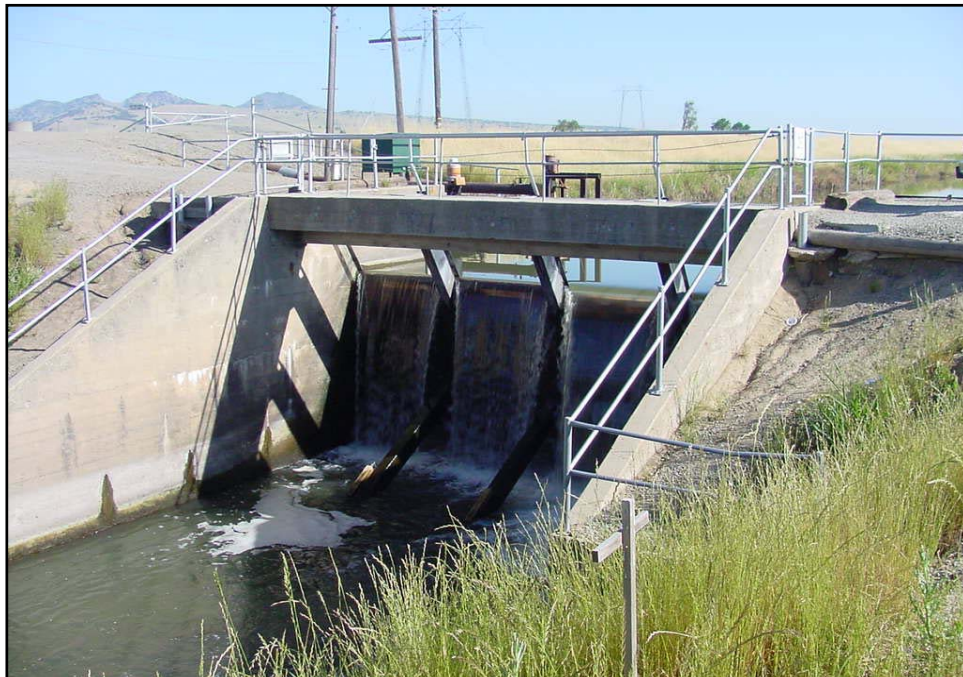
Looking at the downstream side of structure from the left bank levee.

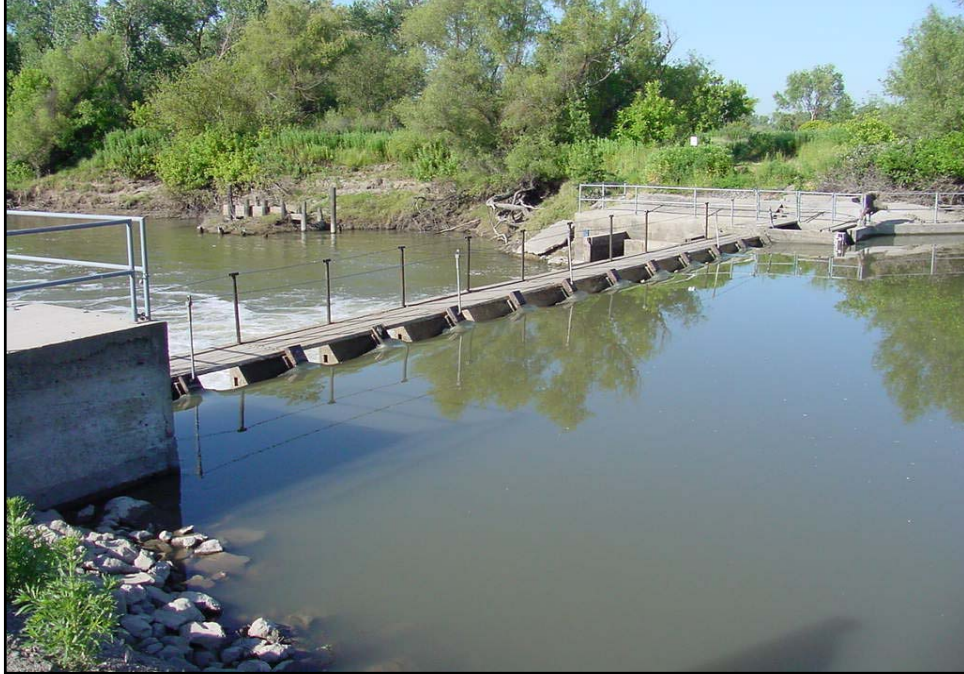
Looking at the upstream side of the structure.

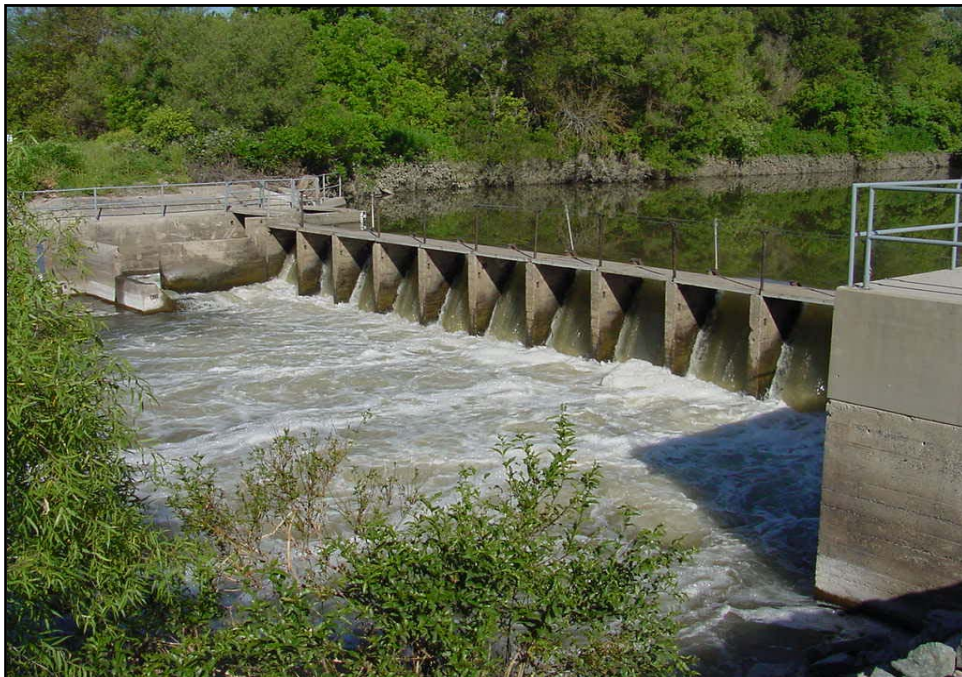
Looking at the downstream side of the structure.
